## North Coast Regional Water Quality Control Board

**Inspection Report for February 10, 2022 Consent Inspection,  
Trinity County  
Assessor's Parcel Numbers (APN) 016-200-17-00 (the "Property")**

File: Cannabis Program Inspections, Trinity County, Baker Property,  
CIWQS Place ID 849792

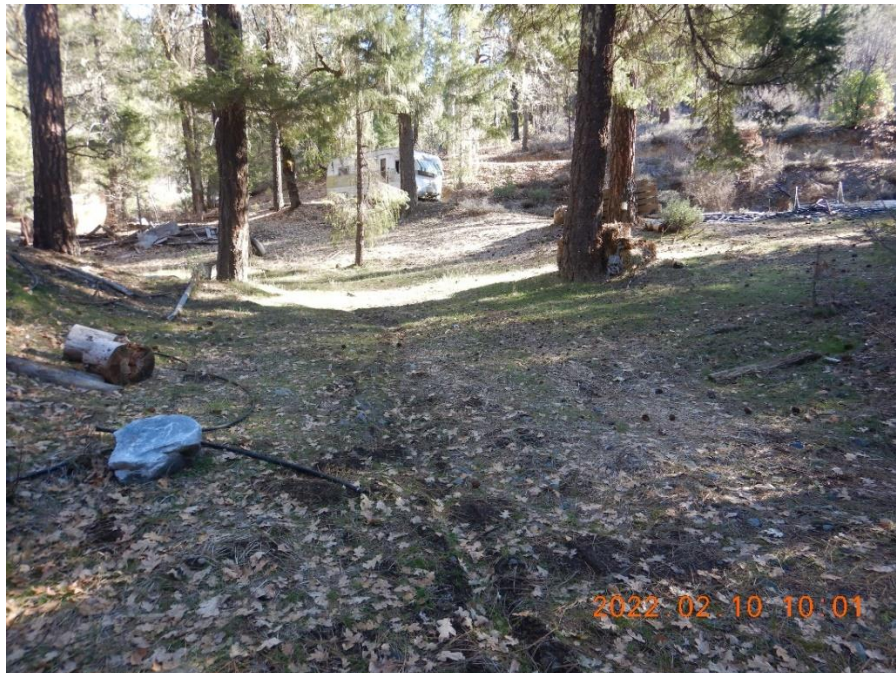
I parked along Highway 3, met with CDFW personnel, and walked east onto the Property. I observed a wooden box that had been constructed to cover the well at WQ1 (Photo 1). I continued walking east and observed that a car, potting soil and refuse which was present during previous inspections, had now been removed from the site (Photo 2 and Photo 3).

*Photo 2—Looking northwest from WQ 1. A car that was present in previous inspection is no longer here.*

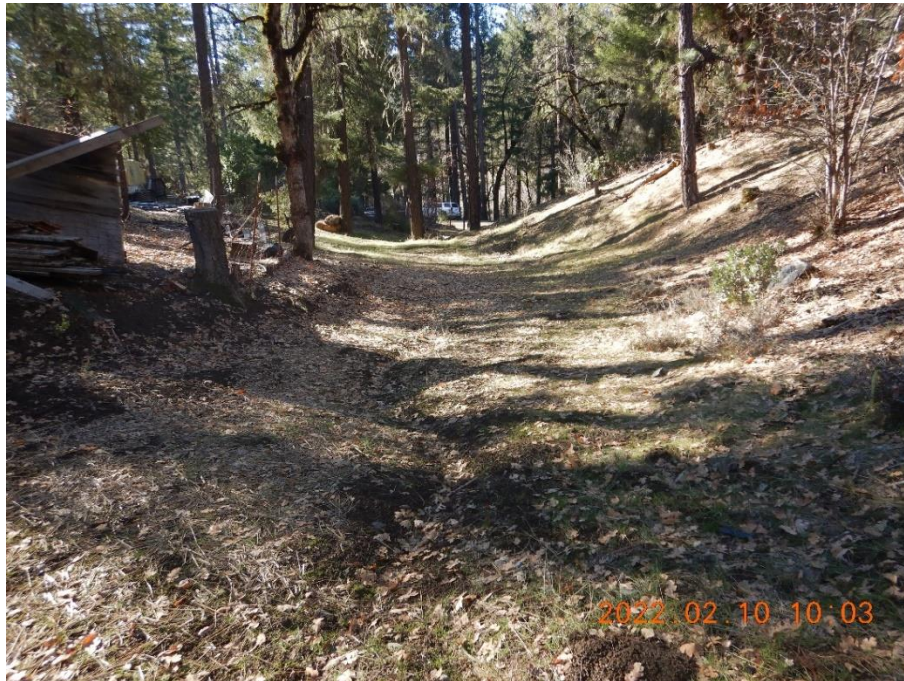
*Photo 3—Looking southeast towards WQ1. Refuse and potting soil that was visible during previous inspections has been removed.*

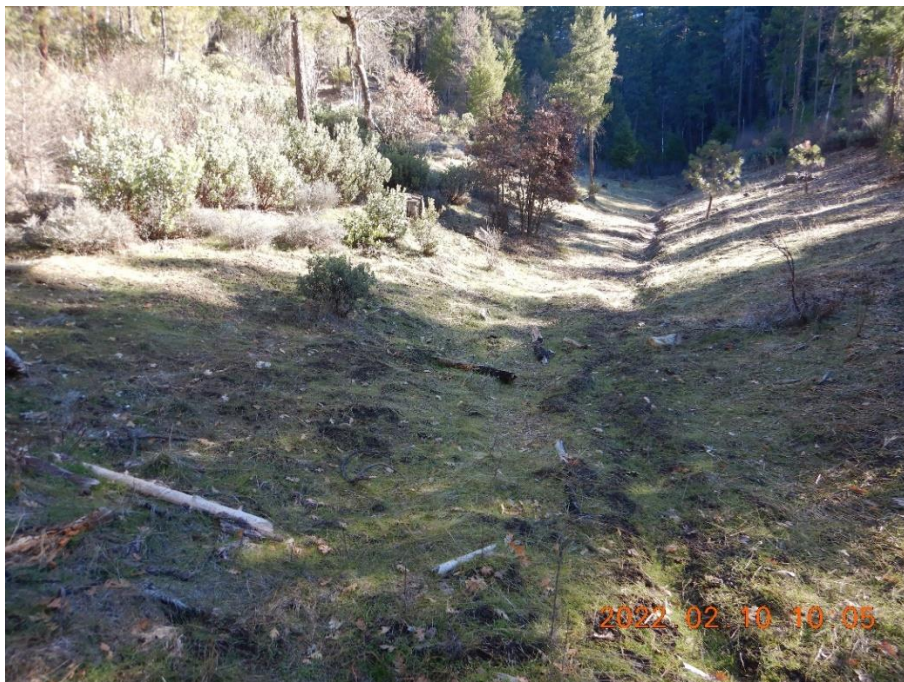
I continued walking east to WQ2 and observed the valley—which was formerly filled with imported potting soils and other cannabis cultivation waste—had now been reshaped and was covered with a layer of straw and leaf litter (Photo 4 and Photo 5). I walked up to the road at WQ3 and observed that angular aggregate had been added to the road surface (Photo 6).

*Photo 4—Looking west in the vicinity of WQ2. A narrow channel is visible where the Approved CRMP proposed constructing one, and the ground is covered with a thin layer of straw and leaf litter. Evidence of imported potting soils and cannabis cultivation wastes, which were visible in past inspections, are no longer visible.*

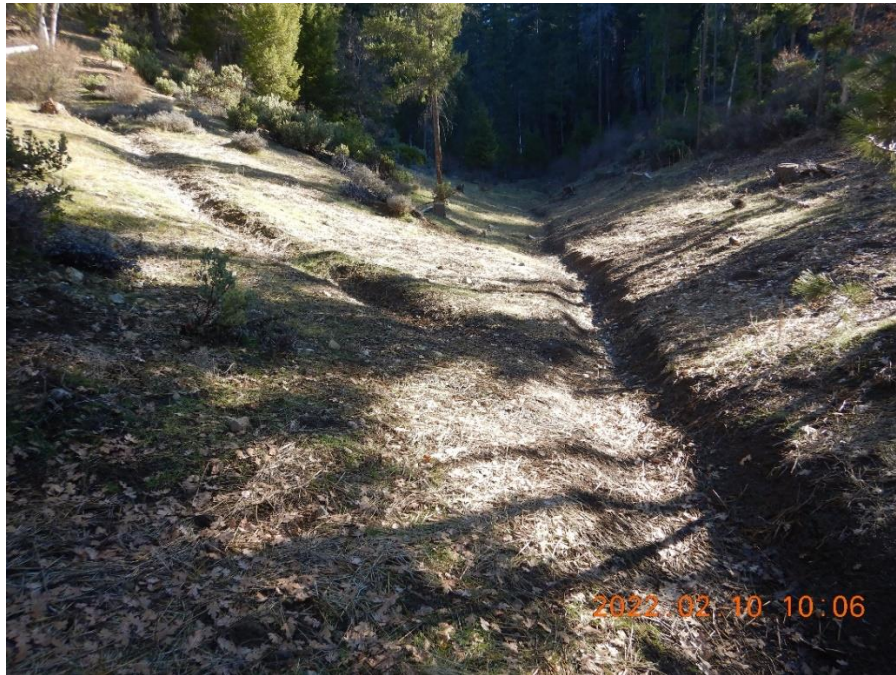
*Photo 5— Looking east in the vicinity of WQ2. Narrow channels are visible where the Approved CRMP proposed constructing them. Earthen garden beds that were present in past inspections, are no longer visible.*

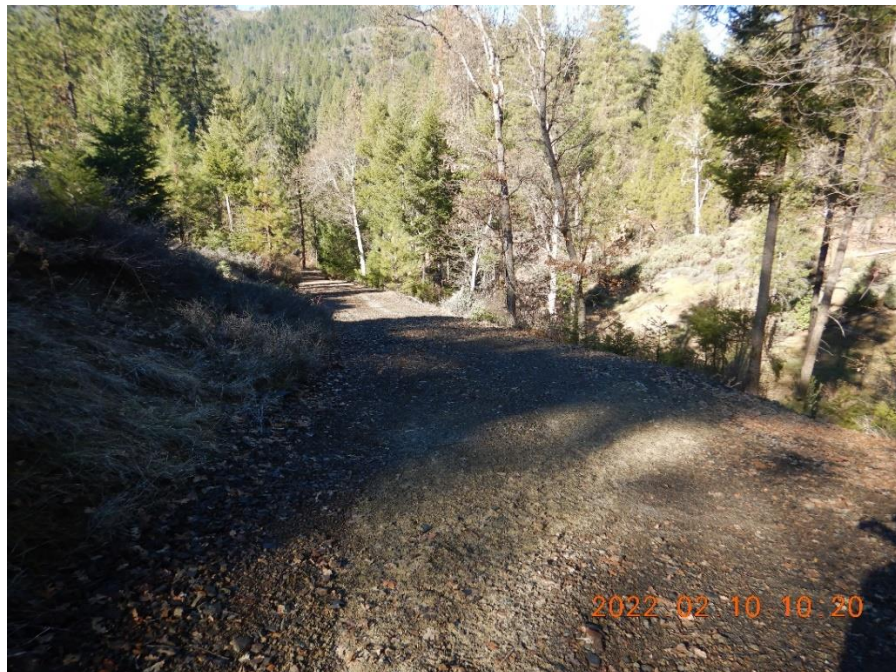
*Photo 6—Looking west toward WQ3 at access road. The road-surface is covered with angular rock.*

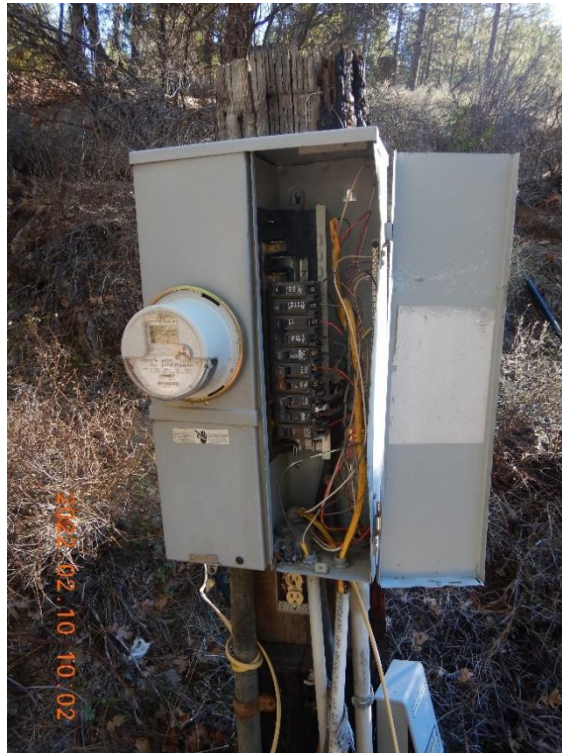
I walked to WQ4 where CDFW personnel and I met with Gayle Baker. Mrs. Baker explained to us that the full scope of work presented in the Approved CRMP was not in her capacity to complete. She explained that her consultant had proposed too large of a scope of work to restore the site and that she and Mr. Baker did not have enough money to purchase the 141 container grown plants that were identified in the Approved CRMP. Mrs. Baker also explained that the power service had been vandalized (Photo 7), which would make it difficult to irrigate the container grown plants.

*Photo 7—Electrical panel located at WQ4. The image shows that wires have been disconnected from the breakers.*

1. Engage a qualified professional to complete implementation of the Approved CRMP—including the full scope of the revegetation plan—or obtain approval

from the Regional Water Board's Executive Officer or his delegate in accordance with CAO General Requirements and Notices No. 10. If you do request changes to the Approved CRMP. Please be sure to include an explanation of how the revised plan will meet all CAO requirements.

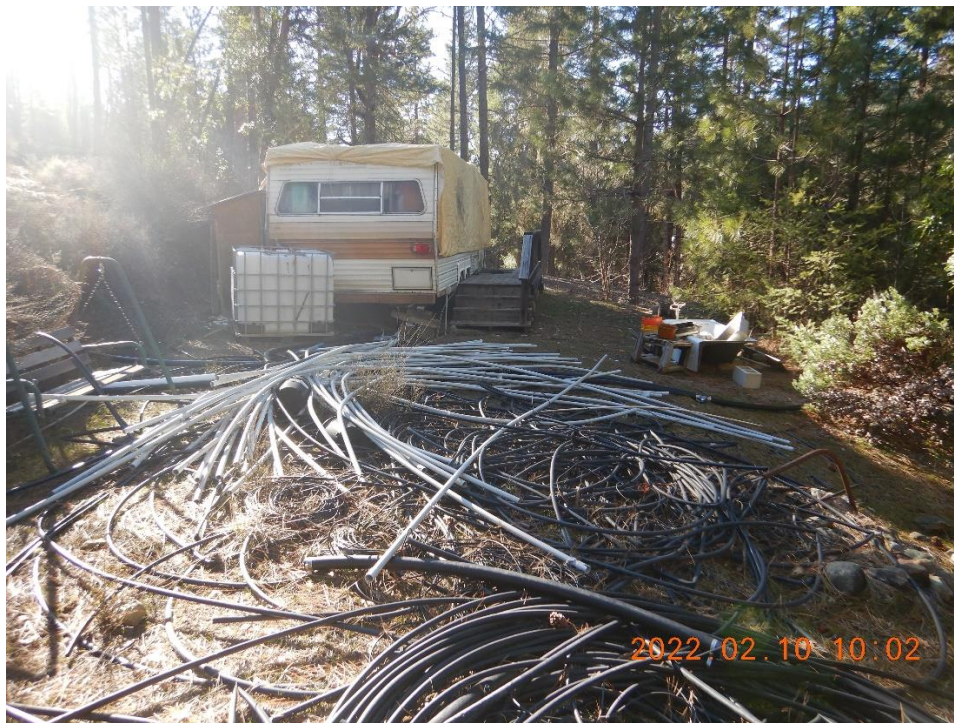
I explained to Mrs. Baker that if conditions had changed, and she no longer believed that the Approved CRMP was appropriate for meeting the requirements of the CAO, she would need to make the case for this in writing to the Regional Water Board Executive Officer. We also identified additional piles of refuse on the property that needed to be disposed of (Photo 8).

*Photo 8—Piles of plastic pipe in the vicinity of WQ4.*

2. Remove or move the remaining trash/refuse on site. If moved somewhere else on site, the trash/refuse must be 150 feet away from any watercourse. Document what is done with the trash/refuse e.g. receipt from the dump, or pics of the new storage location on site.
3. Contact Trinity County Environmental Health at (530) 623-1459 and arrange for them to inspect the wellhead.
